# **An Analysis of Possible Microbiologically Influenced Crevice Corrosion of 316 Stainless Steel in a Seawater Environment**

MASTER OF SCIENCE IN OCEANOGRAPHIC ENGINEERING

MASSACHUSETTS INSTITUTE OF TECHNOLOGY

WOODS HOLE OCEANOGRAPHIC INSTITUTION

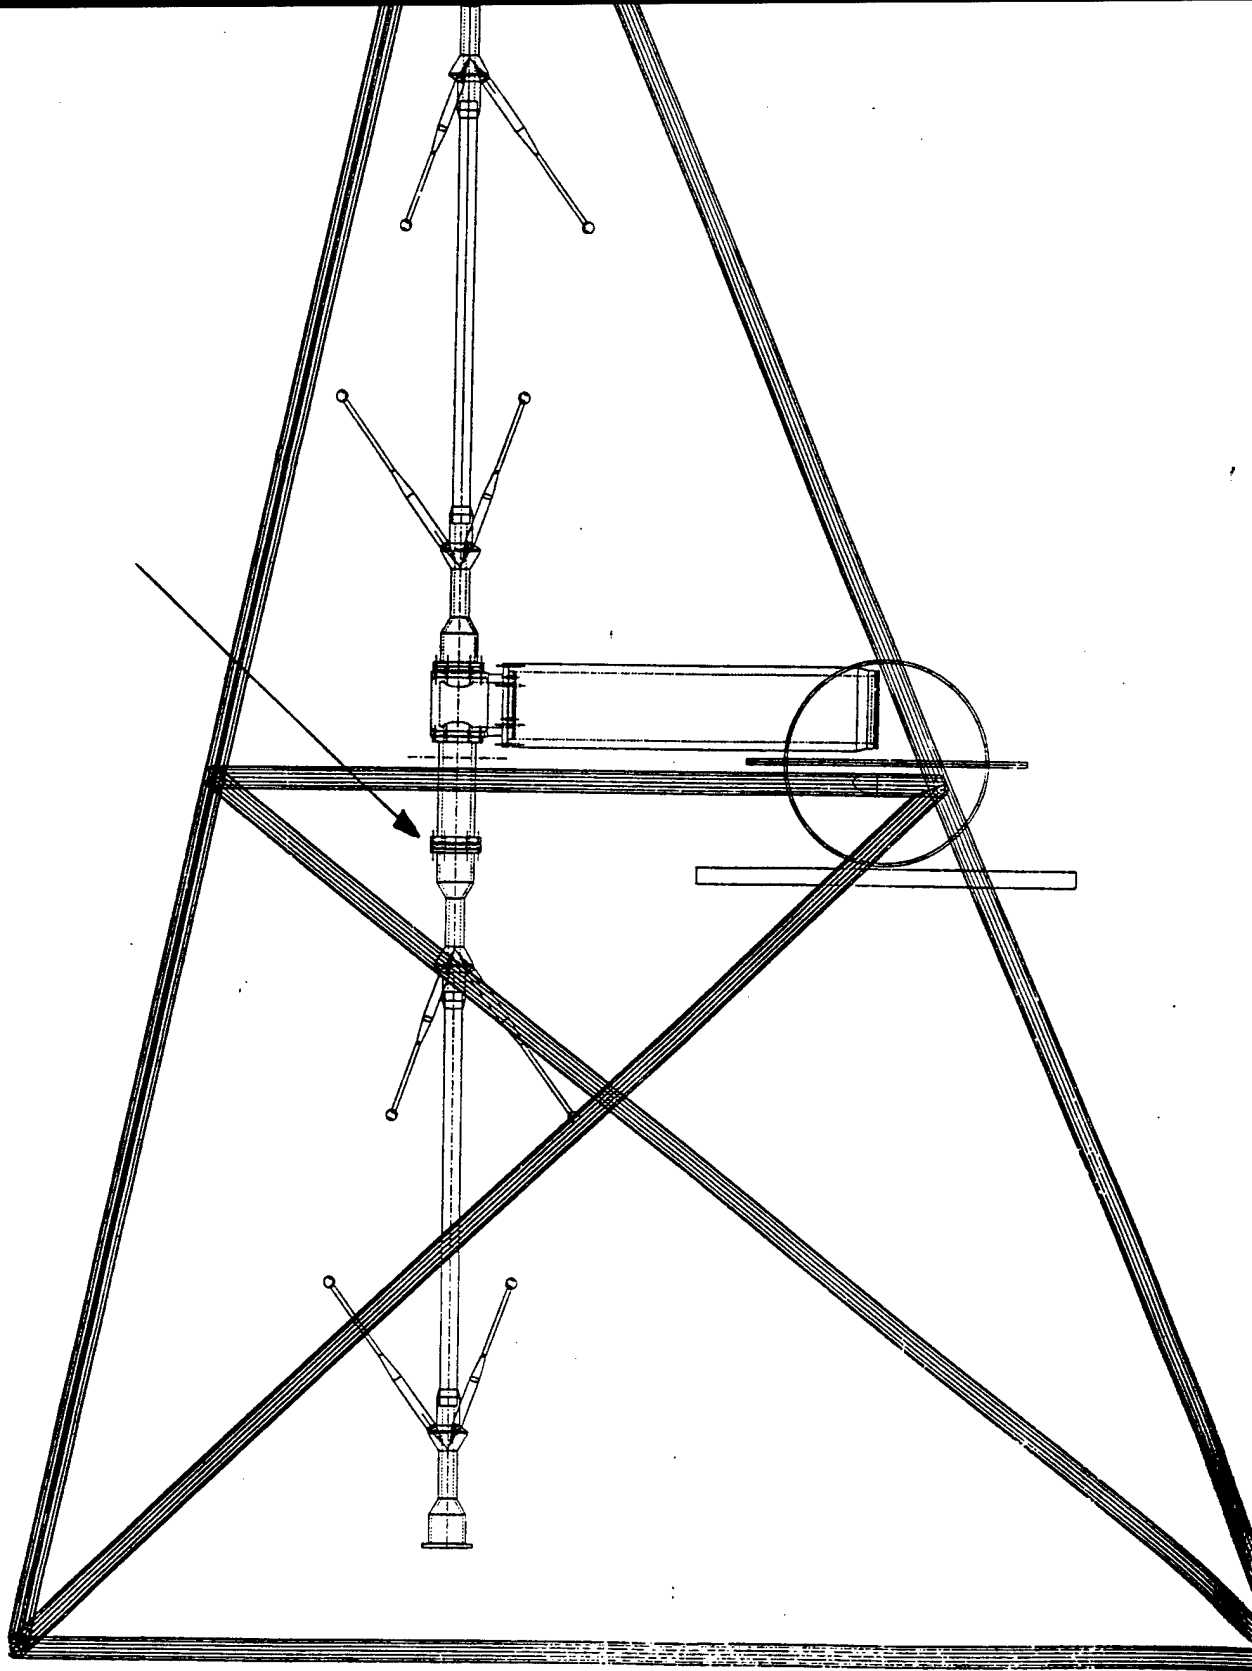
Figure 1-3: Line Drawing of Vorticity Instrument within Support Pyramid

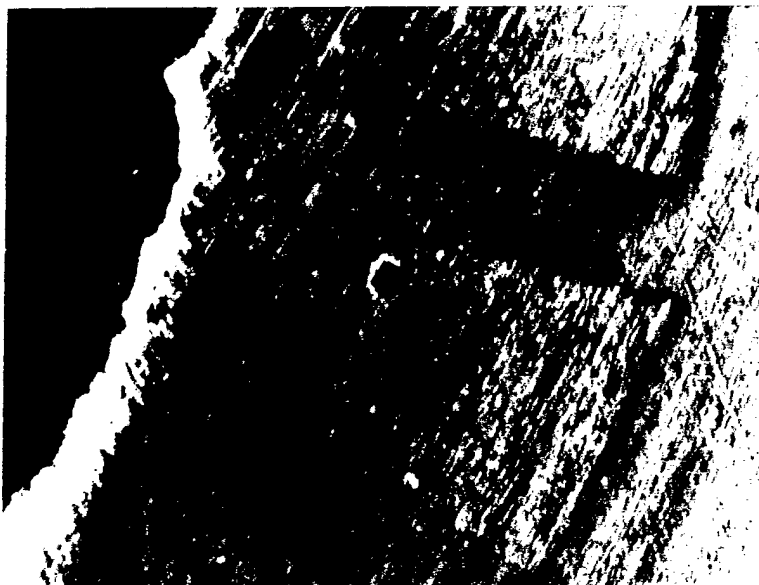
Figure 5-7: Active Seawater Pit (60X magnification)

active specimen. It did display the formation of a single pit at the edge of the crevice region, suggesting that with additional time, more significant corrosion might have occurred.
